USAAEFA PROJECT NO. 75-03

FLYING QUALITIES EVALUATION RU-21A CEFIRM LEADER AIRPLANE

FINAL REPORT

DECEMBER 1974

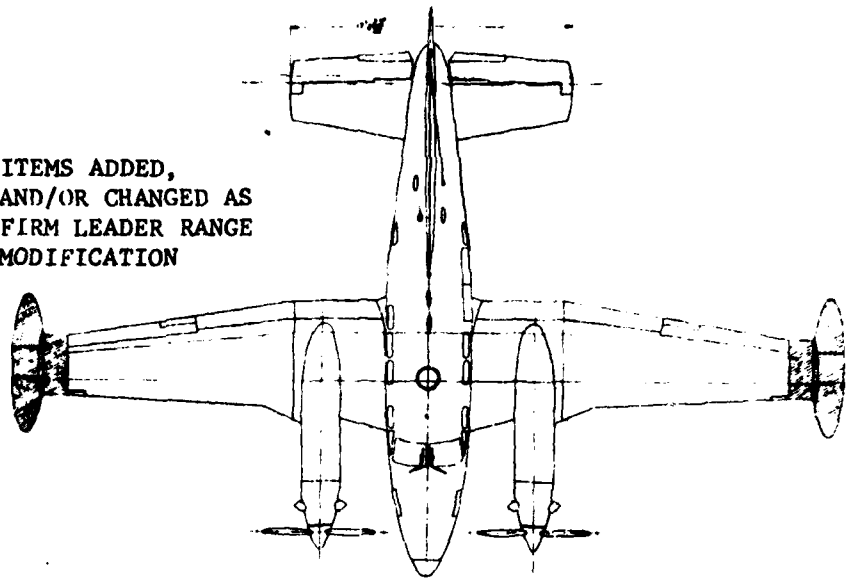
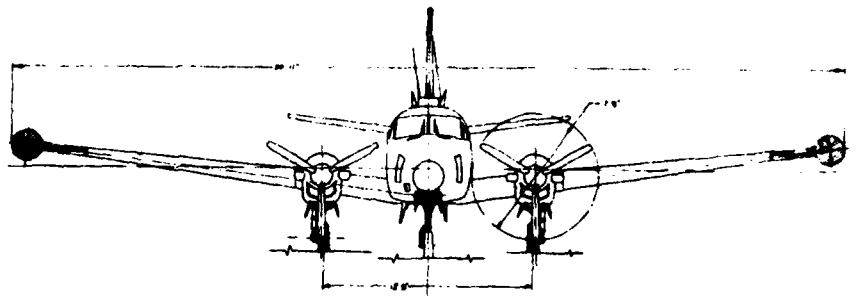
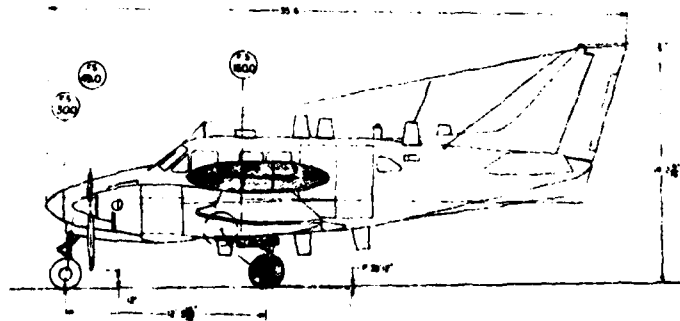
Figure 1. Three-View Drawing, RU-21A CEFIRM LEADER.

2. A three-view drawing showing areas of structural modification is included as figure 1. Photos 1 through 3 show the aircraft and structural details of the tip extension and pod assembly.

INDICATES ITEMS ADDED,
INSPECTED AND/OR CHANGED AS
PART OF CEFIRM LEADER RANGE
EXTENSION MODIFICATION

1. The RU-21A CEFIRM LEADER airplane has the general structure of the RU-21A airplane. Major modifications are listed below.

- a. Maximum gross weight for takeoff increased from 9650 to 10,200 pounds.
- b. Main landing gear tires changed to 8.50 x 10, 10-ply.
- c. Nacelle landing gear doors modified to accommodate the larger tires.
- d. Eighteen-inch spanwise section added to each wing tip.
- e. High-frequency dipole antennas removed from wing.
- f. GUARDRAIL 1-type antennas (22-1/2 inch diameter by 102 inches long) installed on wing tips.

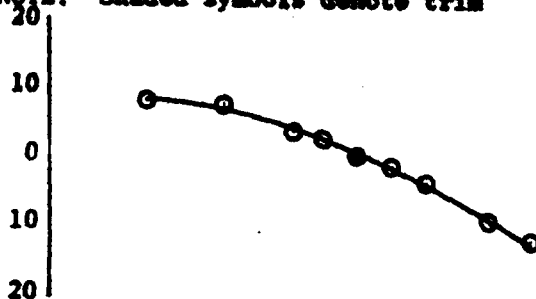
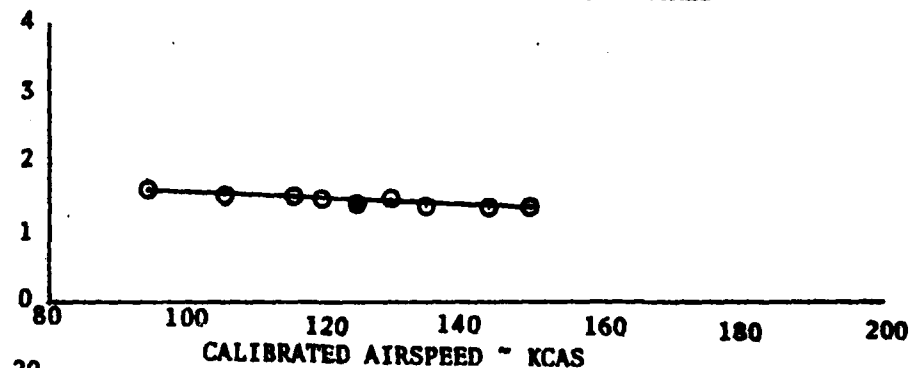
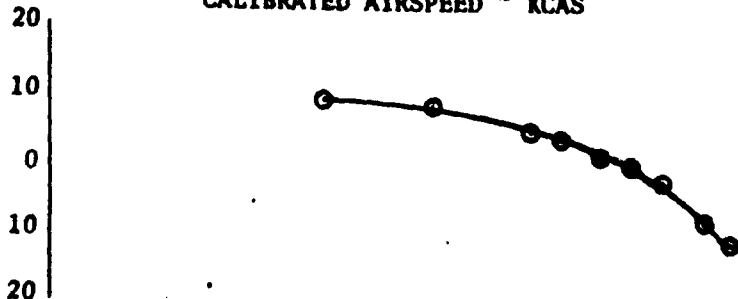
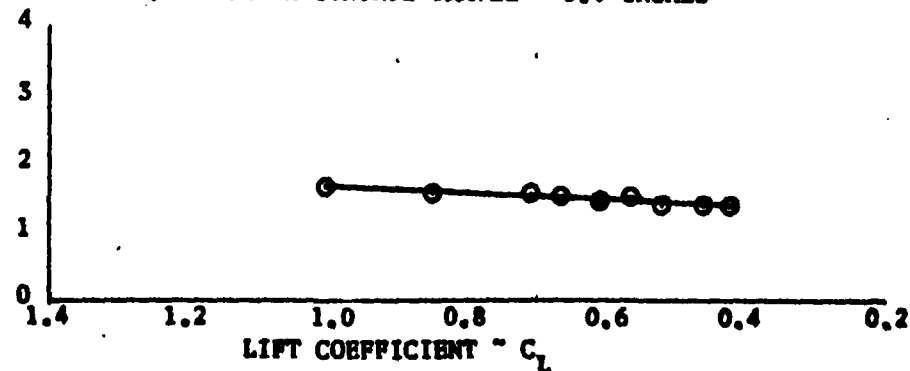
FIGURE 1
Static Longitudinal Stability
RB-21A S/N 67-18113

Avg Gross Weight ~LB	Avg CG Location ~IN	Avg Density Altitude ~FT	Avg OAT ~°C	Configuration	Flight Condition
9340	160.1 (AFT)	6920	11.0	Cruise	Level Flight

NOTE: Shaded symbols denote trim

TOTAL ELEVATOR CONTROL TRAVEL = 8.0 INCHES

7. The static longitudinal stability characteristics of the RU-21A CEFIRM LEADER were evaluated at the conditions shown in table 2. The aircraft was trimmed in steady-heading coordinated level flight at the desired trim airspeed. While maintaining constant power and trim settings, the airspeed was stabilized at 5 to 10-KIAS increments up to 30 KIAS greater or less than the trim airspeed. Longitudinal control forces and positions were measured and test results are presented in figures 1 through 3 of appendix C.

8. The static longitudinal stability, as indicated by the variation of stick force with airspeed about the trim airspeed, was positive in both the CR and PA configurations. Stick force gradients were more shallow on the low-speed side of trim than on the high-speed side of trim. At airspeeds approaching a stall in the PA configuration, the stick force gradient became essentially neutral. Though static longitudinal stability in the WO configuration was not specifically tested, stall testing revealed that in the WO configuration the stick force gradient actually reversed and near-zero stick force was required at 60 KIAS (para 24). Static longitudinal stability, as indicated by the variation of elevator control column position with airspeed, was slightly positive in the CR configuration. In the PA configuration, the elevator control position gradient was neutral. Although during this test a 60-KIAS band around trim required only 1/4 inch of control displacement, the shallow control position gradients were not objectionable, due to the positive elevator force cues to airspeed variation from trim. The static longitudinal stability of the CEFIRM LEADER airplane at an aft cg position did not meet the requirements of MIL-F-8785B(ASG), paragraph 3.2.1.1, in that in the PA configuration, an aft trim position of the elevator control was not required to maintain an airspeed slower than trim and a forward elevator control position was not required to maintain an airspeed faster than trim airspeed. Within the scope of this test, the static longitudinal stability of the RU-21A CEFIRM LEADER is satisfactory because of the adequate force cues.

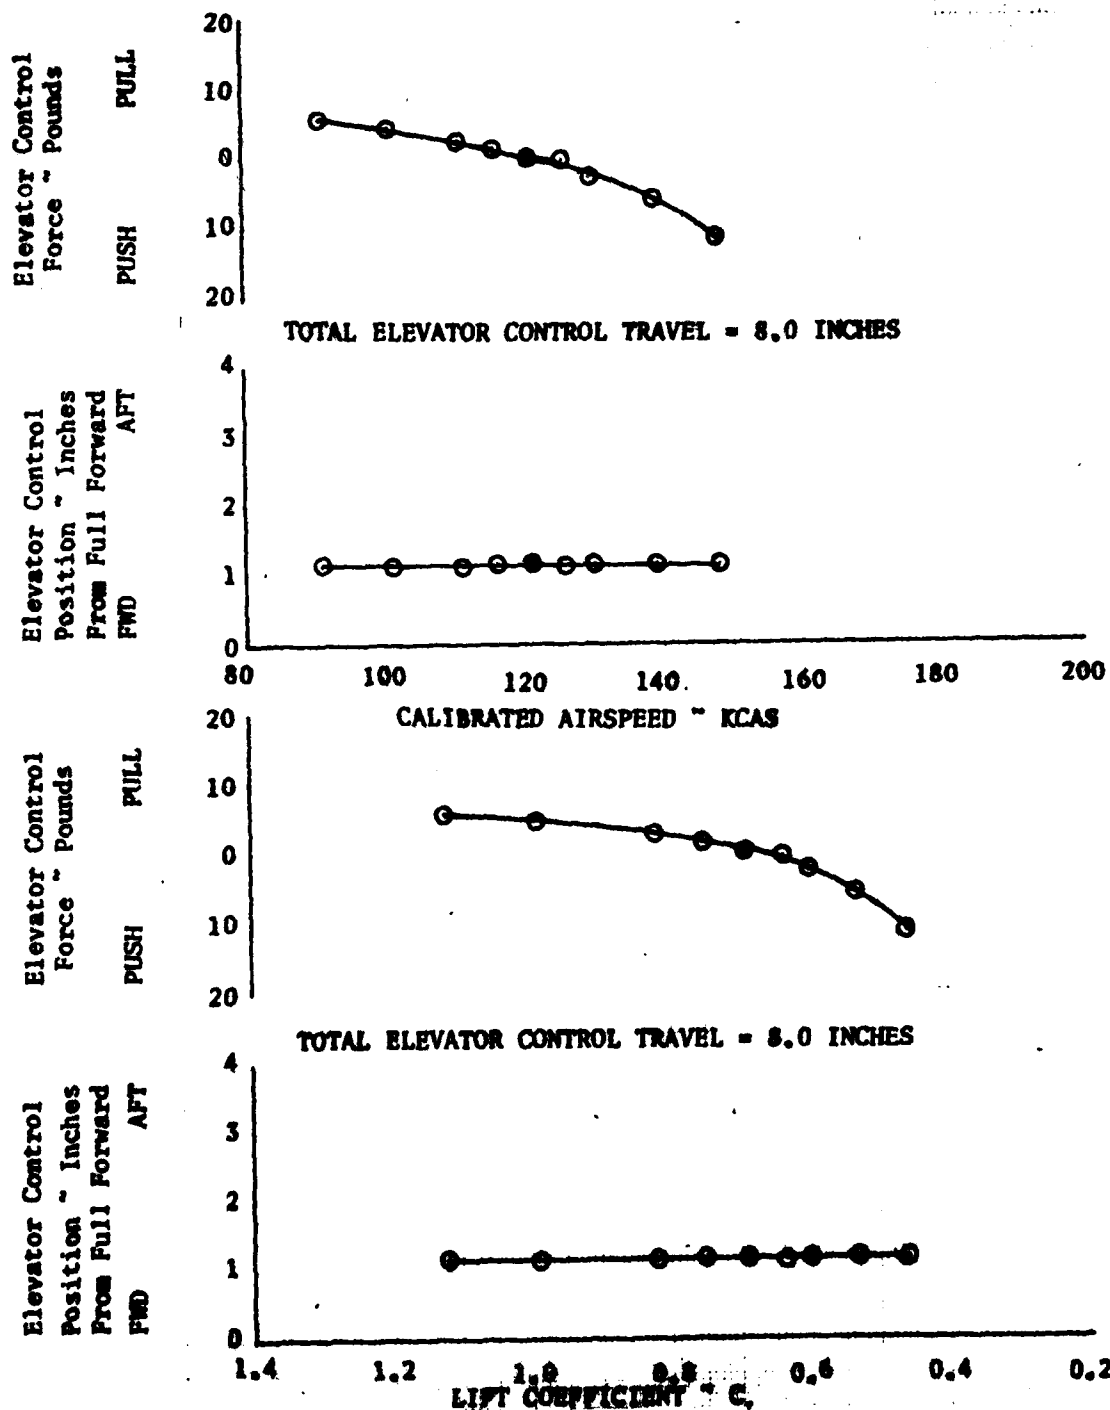
FIGURE 3
Static Longitudinal Stability

Avg Gross Weight ~LB	Avg EG Location ~IN	RU-21A Avg Density Altitude ~FT	S/N 67-18115 Avg OAT ~°C	Configuration	Flight Condition
10040	159.6(AFT)	7400	12.0	Power Approach	Level Flight

NOTE: Shaded symbols denote trim
